Provide an overview of the **Cosumnes Power Plant (CPP)** steam turbine generator stator ground fault failure and approve the proposed amendment to the **2022 SFA Budget Resolution** to augment the Capital Expenditures line item by \$18.61 million for **Sacramento Municipal Utility District Financing Authority (SFA)**.

Board Finance & Audit Committee and Special SMUD Board of Directors Meeting
Tuesday, October 18, 2022, scheduled to begin at 5:30 p.m.

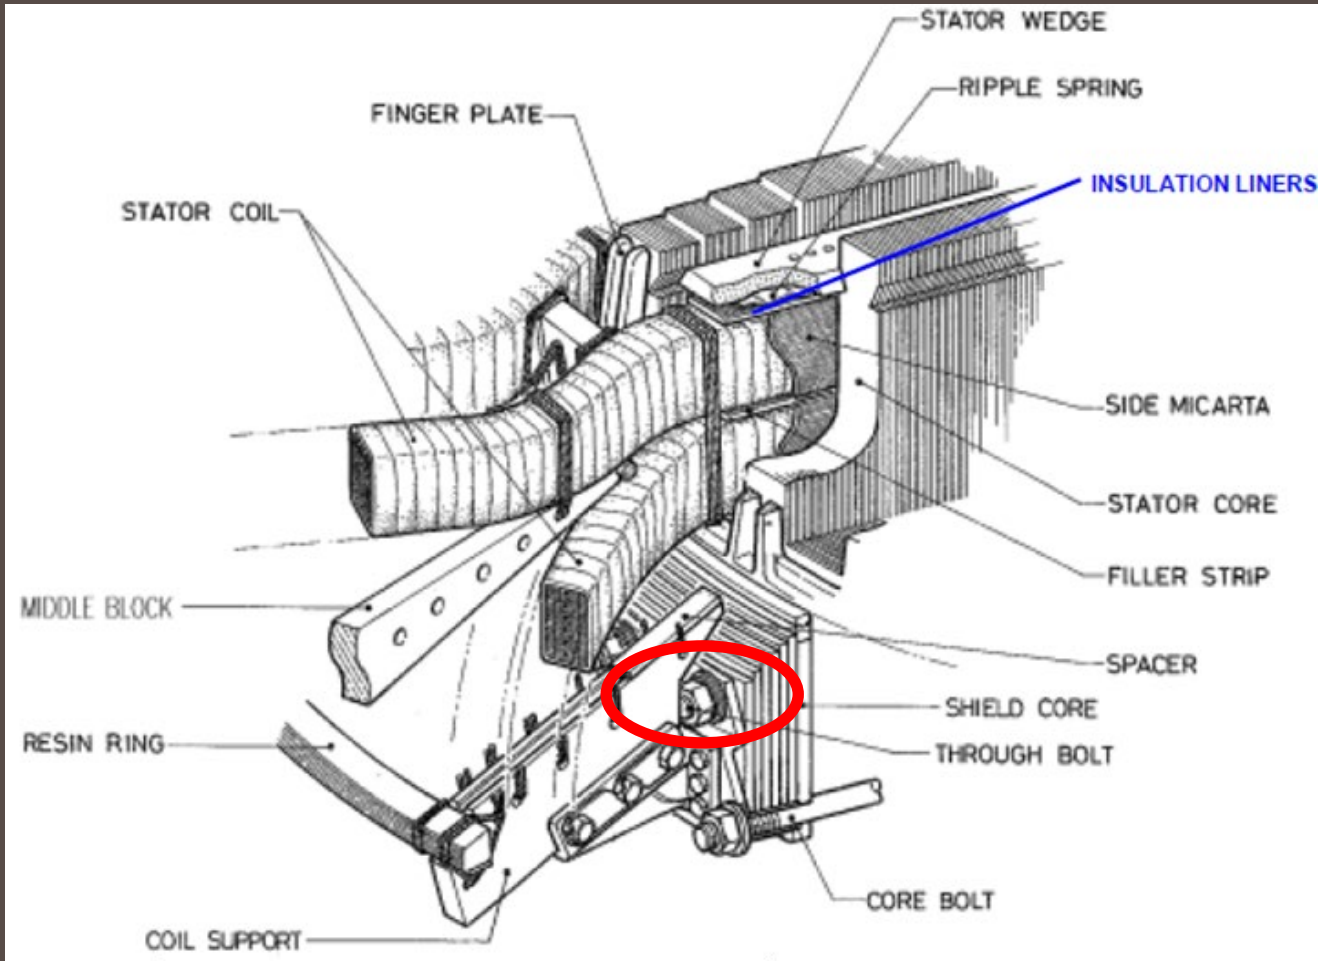
What caused the Ground Fault Failure

- **Through-bolt came into contact with the core** which caused the stator ground fault.
- The Root Cause Analysis (RCA) indicates **insulation surrounding the through-bolt had failed** which resulted in contact with stator core.
- The most plausible cause for the failure of the through-bolt insulation is **abrasion or wear of the insulation caused by relative motion** between the through bolts and core iron laminations while they were in contact.

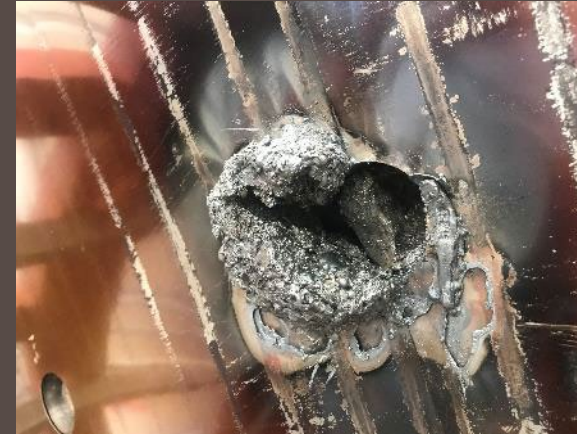
Through Bolt following removal

Through bolt through lamination

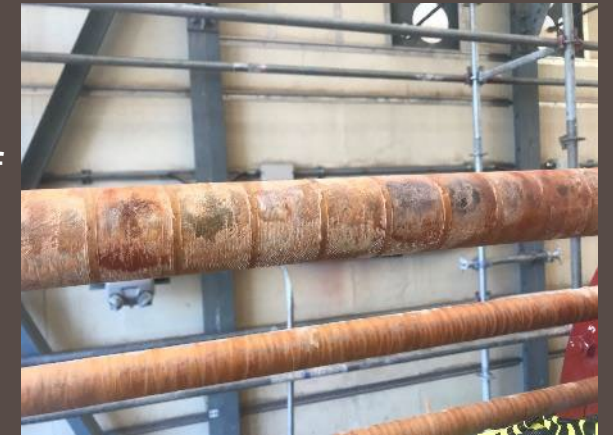
Deterioration of Insulation
