*Customer Advanced Technologies Program
Special Report*

Operation: IDEC System Rescue

Dave Bisbee, CEM
Sacramento Municipal Utility District
November 7, 2002

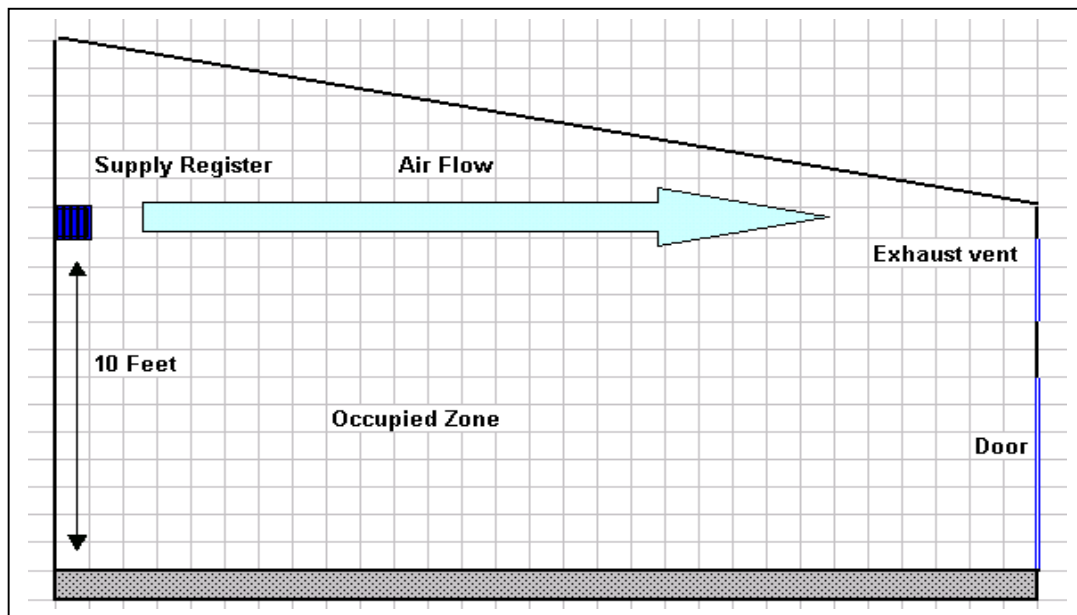
- Since the IDEC units were mounted on the roof, most of the ductwork was exposed to direct sunlight. When the outside temperature was 100°F, the measured surface temperature of the ductwork exceeded 150°F. *This added a considerable amount of heat to the air being supplied to the classrooms.*
- The supply air duct registers were located approximately 10 feet above the floor. The exhaust vents were located above the entrances to the classrooms. *Because the supply air was not directed downward, most of it completely bypassed the occupied portions of the classrooms* (refer to the diagram below).

- ❑ IDEC units were thoroughly cleaned
- ❑ The exterior of the exposed ductwork was treated with heat reflective coating
- ❑ Supply registers were adjusted to direct the supply air downward into the occupied zones of the classrooms

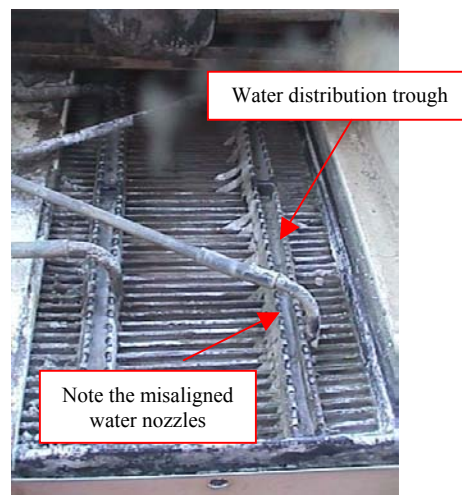
Several of the water distribution nozzles were misaligned and were not delivering the water into the water troughs (see photo). Consequently, water was being distributed over an extremely limited portion of the evaporative cooling media. *This dramatically reduced the cooling capacity of these IDEC units. In fact, the water troughs for one IDEC unit were completely missing.*

- ❑ Water distribution nozzles were adjusted to deliver the water into the distribution troughs
- ❑ Missing water troughs were replaced.
- ❑ A faulty water circulation pump was replaced

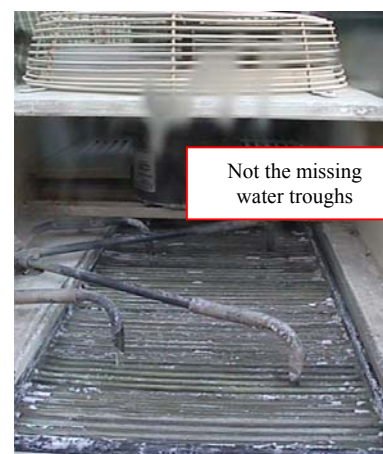
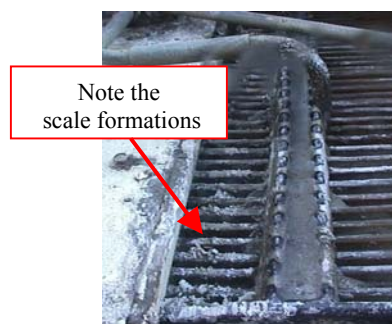
- One of the IDEC units had a defective circulation pump—and, as a result, *this unit’s indirect evaporative cooling stage was completely inoperative.*
- The IDEC units had significant problems with scale. Most of the scaling was due to the lack of provisions for water bleed or blow down.

Whenever water is evaporated, most of the impurities contained in the water are left behind and fall back into the basin (or sump) of the unit. As this process is repeated, total dissolved solids becomes very high and scale forms easily on the heat-transfer surfaces of the direct and indirect stages.

According to the manufacturer’s installation guidelines, these units are supposed to be equipped with controls to periodically or continuously bleed off water from the sump. The water that is bled off is replaced by incoming water (i.e. make-up water). These controls help reduce the hardness of the water within the sump and reduce the formation of scale. *None of the IDECs were equipped with bleed controls.*

- ❑ Units were equipped with water bleed (i.e. blow down) controls
- ❑ ABC Staff were provided with training regarding basic system operation, routine and seasonal maintenance requirements
