# 2018 Amphibian and Aquatic Reptile Monitoring Report Sacramento Municipal Utility District

Hydro License Implementation • June 2019 Upper American River Project FERC Project No. 2101

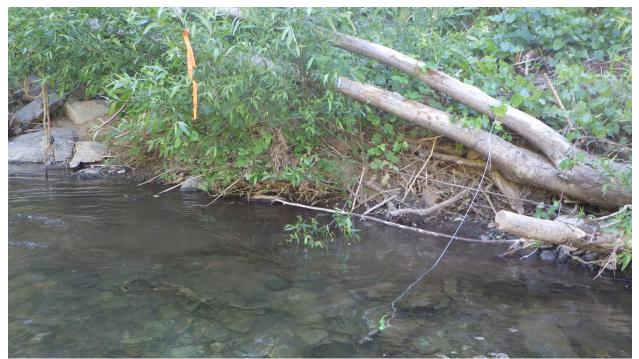
The temperature loggers were housed within metal cylinders and anchored to trees or large boulders using 1/8th-in stainless steel cable; cable loops were secured with aluminum crimping sleeves (Figure 5). Loggers were secured inside the housing using two (redundant) brightly colored nylon zip ties with the excess zip tie material left in place to help relocate the logger in the event of burial of the housing. Loggers were periodically checked on during VESs and cleaned of any debris or gravel around the cylinders. Temperature logger location photos are provided in Attachment 2.

Figure 5. Temperature Data Logger Set-up at Monitoring Site SCD-A1 (June 5, 2018)

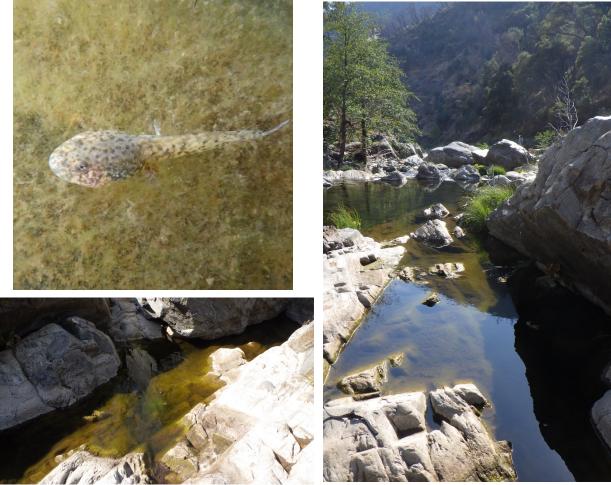
Figure 8. Foothill Yellow-legged Frog Tadpole (Top Left) Found in Side-channel Pool Habitat (Bottom Left and Right) at Site CD-A3 on September 4, 2018

Three FYLF tadpoles and one FYLF young-of-year were documented at one location within Site CD-A3 in 2018 (Table 5, Figure 6 and Figure 8). The tadpoles were observed on September 4 during an adaptive management survey following a brief spill event at Camino Dam. They were observed in a connected side pool with no observable flow, located on the right river bank. The dominant substrate was bedrock and the bottom of the pool was covered with algae. The pool was separated from the main channel by surrounding bedrock and was hydrologically connected to the main channel only at its downstream end (Figure 8). Total water depth at the tadpoles was 0.08 m (0.3 ft). One tadpole was captured; it was 55 mm (2.2 in) long and its Gosner stage was estimated at 37 to 38. The other two tadpoles were similar in length and Gosner stage. A FYLF young-of-year was observed during VES 4 on October 2, perched on bedrock adjacent to the same pool in which the tadpoles were observed on September 4. This frog was not captured. Its estimated length was 20 mm (0.8 in) and estimated Gosner stage was 45 to 46.

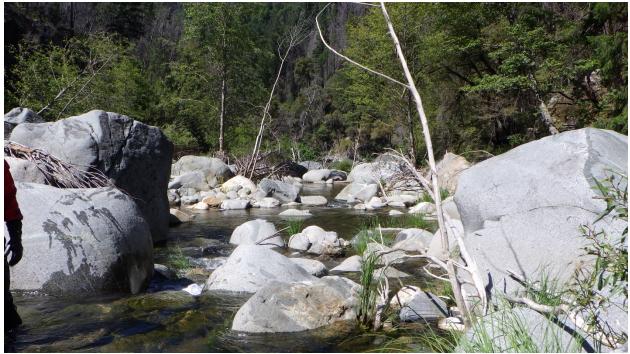
Figure 11. Stripped Riparian Vegetation along Silver Creek, Site CD-A4, June 19, 2018

Habitat conditions along the Silver Creek sites (CD-A3 and CD-A4), the Rock Creek site (RC-A1), and the SF American River site (SCD-A1) were similar to conditions observed during 2017 monitoring (Figures 11–16). The decreased cover along the channel and banks caused by the high stream flows during the wet 2017 water year persisted in 2018. The increased sun exposure resulting from this loss of cover to the channel led to continued presence of benthic algae at all sites in 2018. Additional habitat photos are provided in Attachment 3.

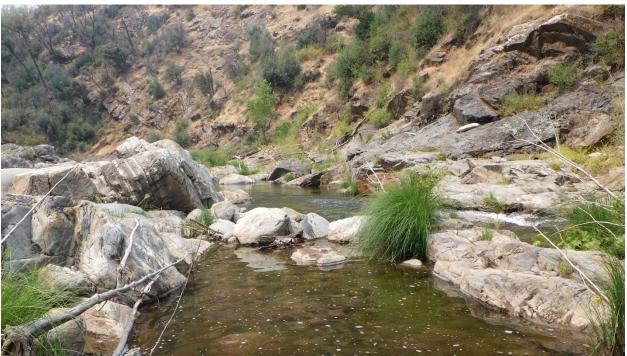
Figure 12. Stripped Riparian Vegetation along Silver Creek, Site CD-A3, July 30, 2018

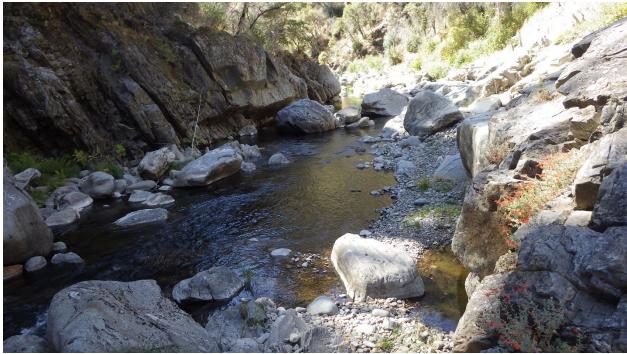
Figure 13. Cobble Bank on Silver Creek, Site CD-A3, October 2, 2018

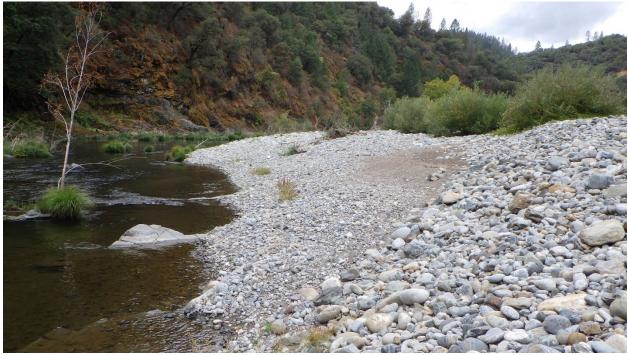
Figure 14. Cobble Bank on SF American River, Site SCD-A1, October 4, 2018

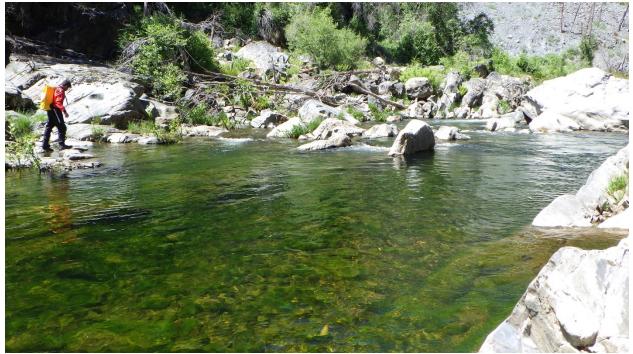
Figure 15. Benthic Green Algae in Silver Creek, Site CD-A3, June 4, 2018

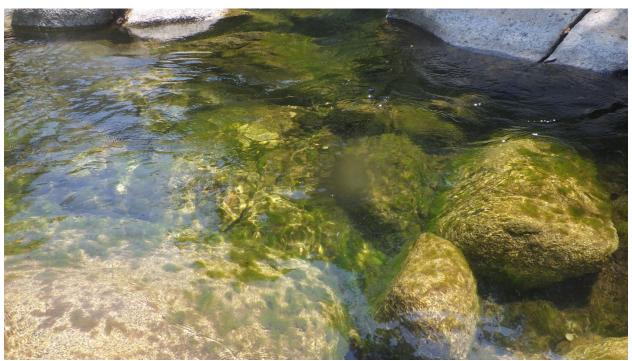
Figure 16. Benthic Green Algae in Rock Creek, Site RC-A1, August 2, 2018
