Sacramento Municipal Utility District Oveja Ranch Solar Project

FINAL Aquatic Resource Delineation Report
September 2024

Prepared by: Shannon Henke, AECOM Biologist

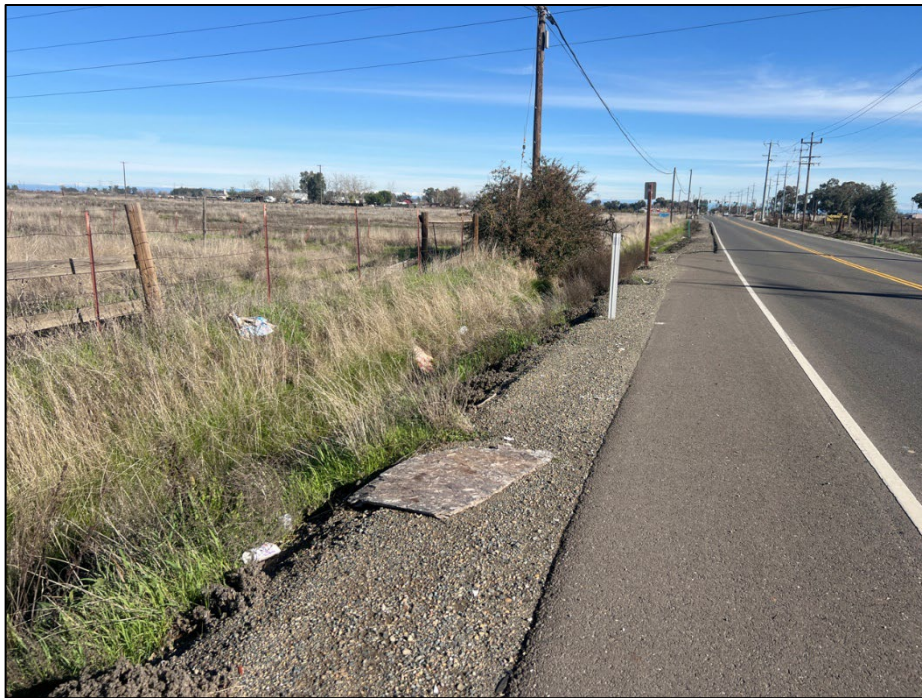
Photo 1. Roadside ditch (RS-1) along Florin Road, a developed landcover type. View east, January 10, 2024.

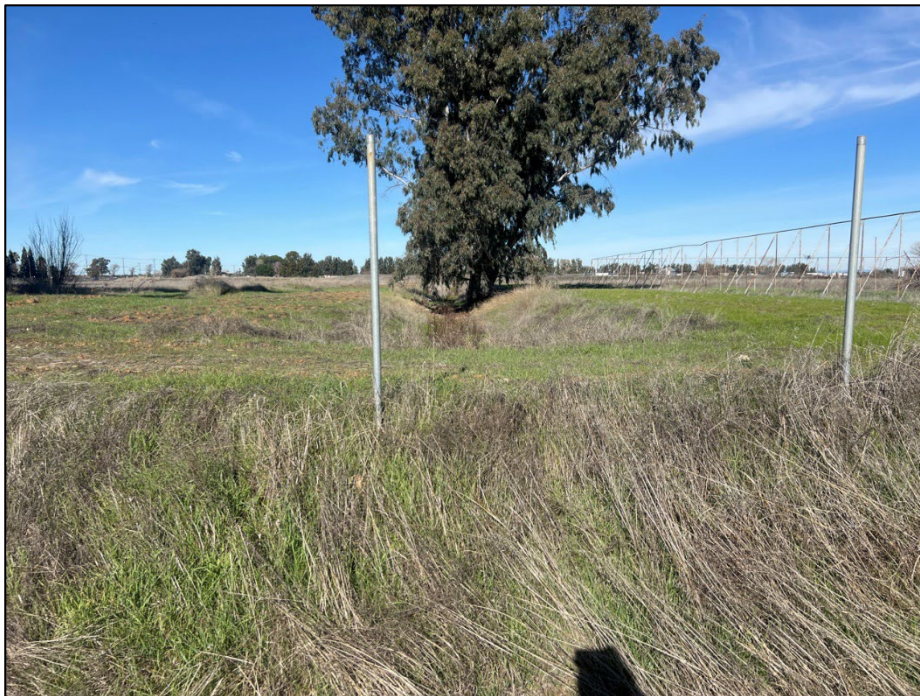
Photo 2. Ephemeral stream (ES-1) appears to be manmade and is surrounded by valley grassland landcover. View north, January 10, 2024

ES-1 is in the northwestern portion of the powerlines on the north side of Florin Road, appears to be manmade, and has an OHWM that is 5 feet wide. ES-1 is not included in the NHD or NWI, though an ephemeral stream is mapped to the west of the feature in the NDH (USFWS 2023, USGS 2024), which was not observed during the field survey.

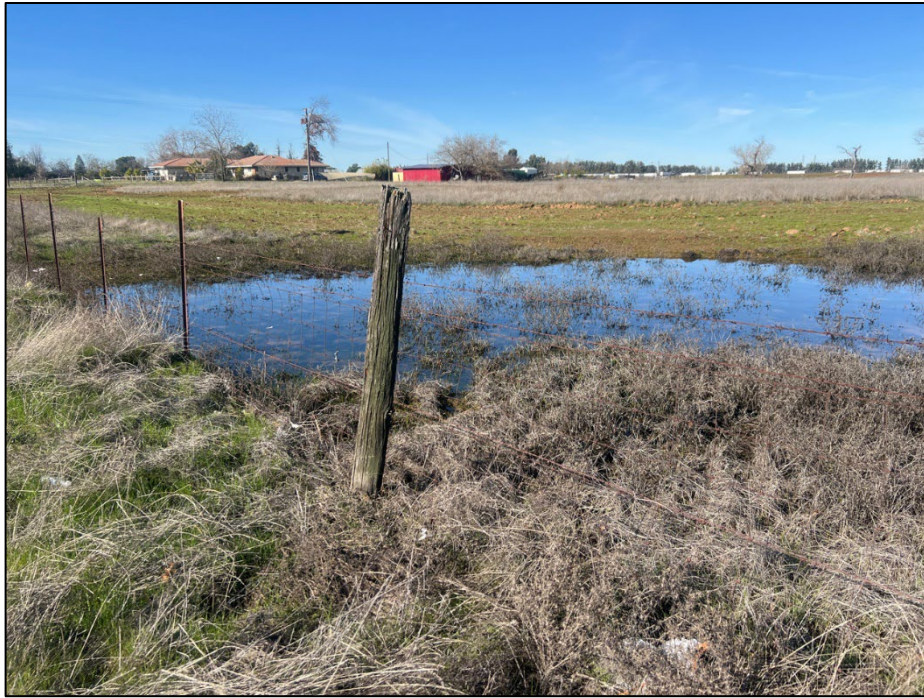
Photo 3. Seasonal wetland (SW-1) is a depressional feature that was inundating during the site visit. View northwest, January 10, 2024.

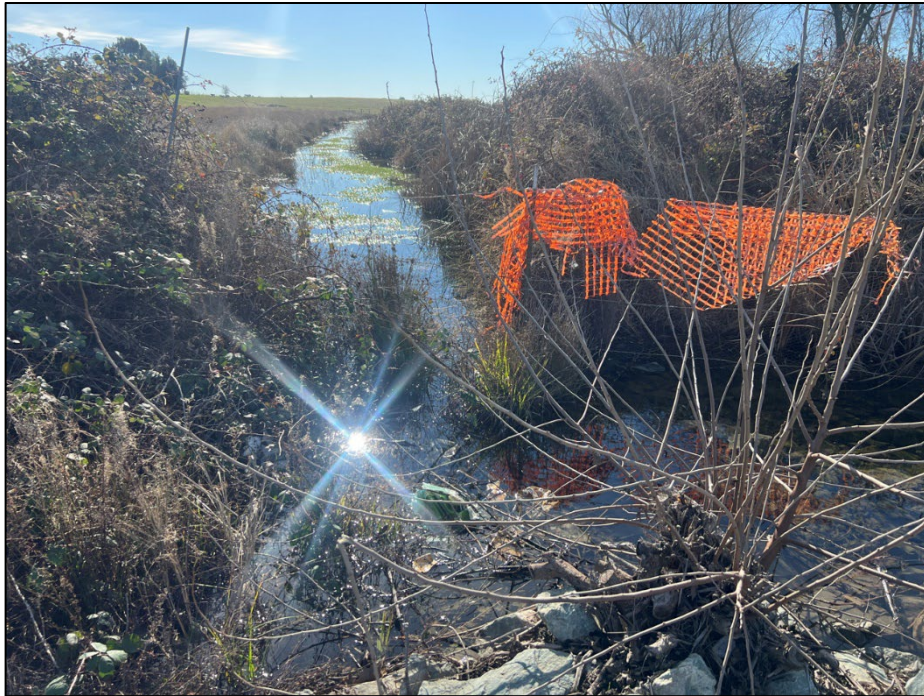
Photo 4. Perennial stream (PS-1) is located on the south side of Florin Road and flows south. View south, January 10, 2024.

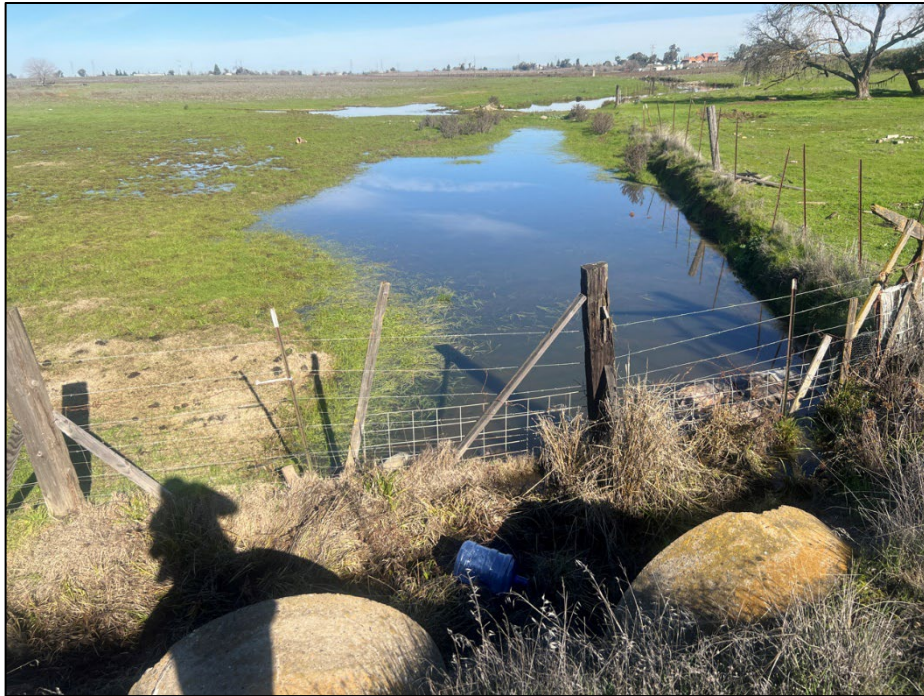
Photo 5. Ephemeral stream (ES-2a) is on the north side of Florin Road and is surrounded by valley grassland habitat. View north, January 10, 2024.

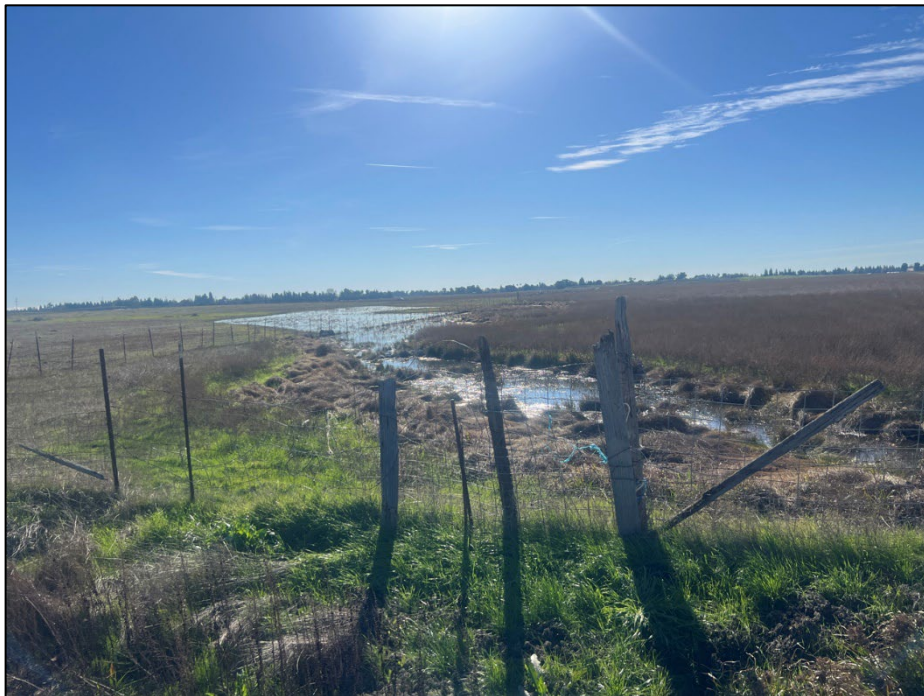
Photo 6. Seasonal wetland (SW-3a) is on the south side of Florin Road is reported by the NHD as an artificial path that flows north into an ephemeral stream. January 10, 2024.

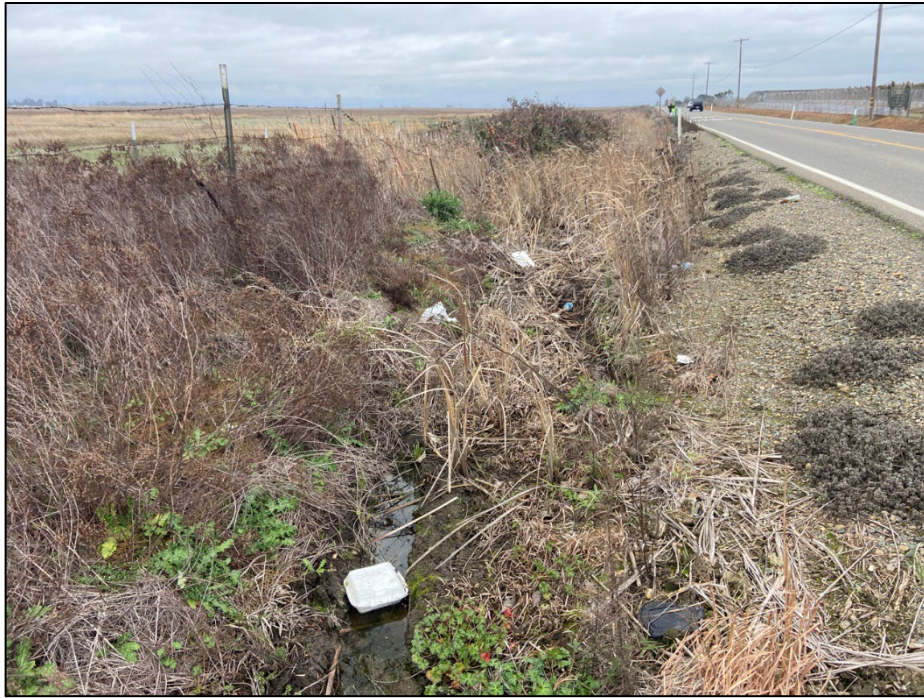
Photo 7. Freshwater marsh (FM-1) occurs along the north side of Florin Road east of the intersection of Excelsior Road. It is dominated by narrow leaf cattail. View east, January 10, 2024.

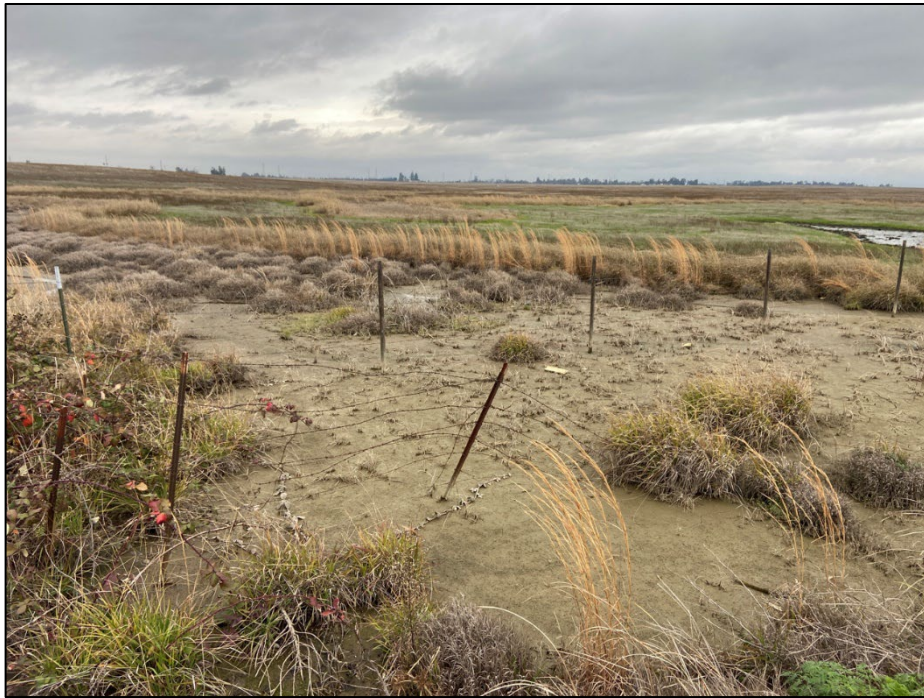
Photo 8. Gerber Creek is an intermittent stream (IS-1a) that occurs along the north side of Florin Road east of the intersection of Excelsior Road. It is associated with OHWM Data Form 1. View northeast, January 10, 2024.

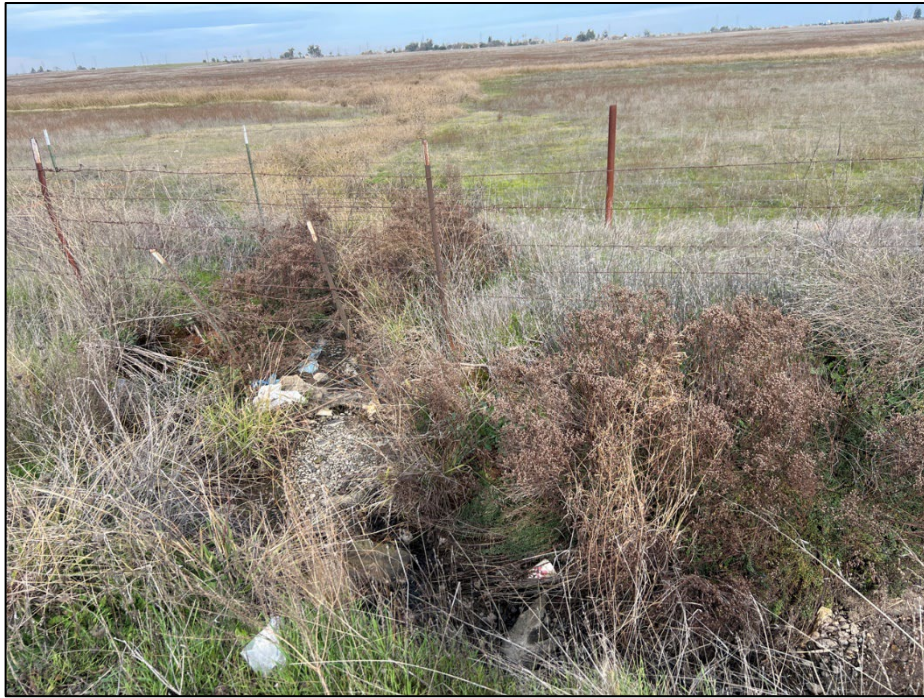
Photo 9. Ephemeral stream (ES-3) surrounded by valley grassland and is on the north side of Florin Road. View northwest, January 12, 2024.

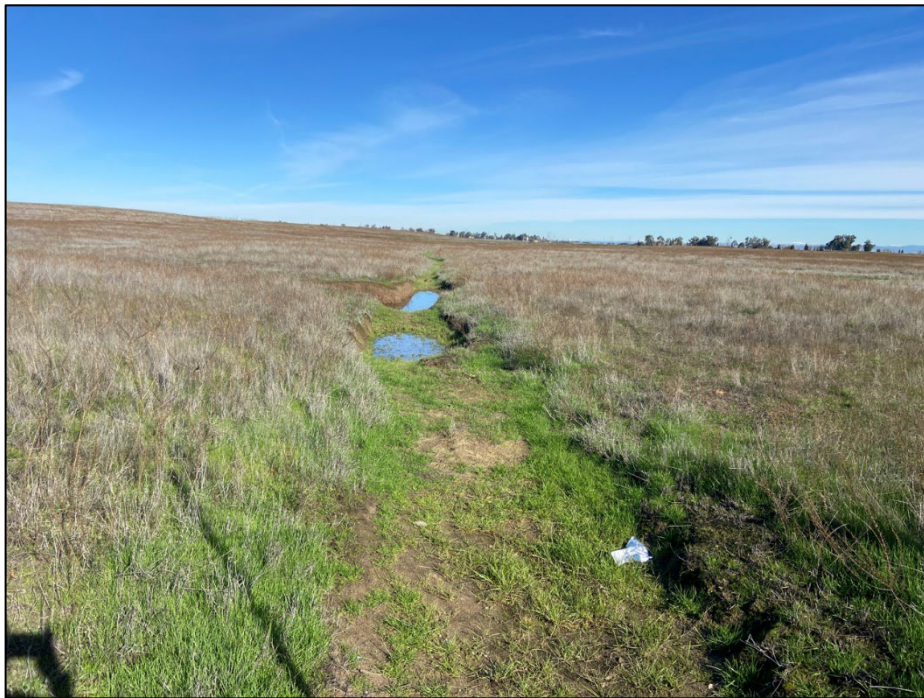
Photo 10. Frye Creek is an intermittent stream (IS-2) that occurs in the 69 kV portion of the study area and is conveyed under Florin Road. View of the northern segment (IS-2a) which is associated with OHWM Data Form 2. View north, January 11, 2024.

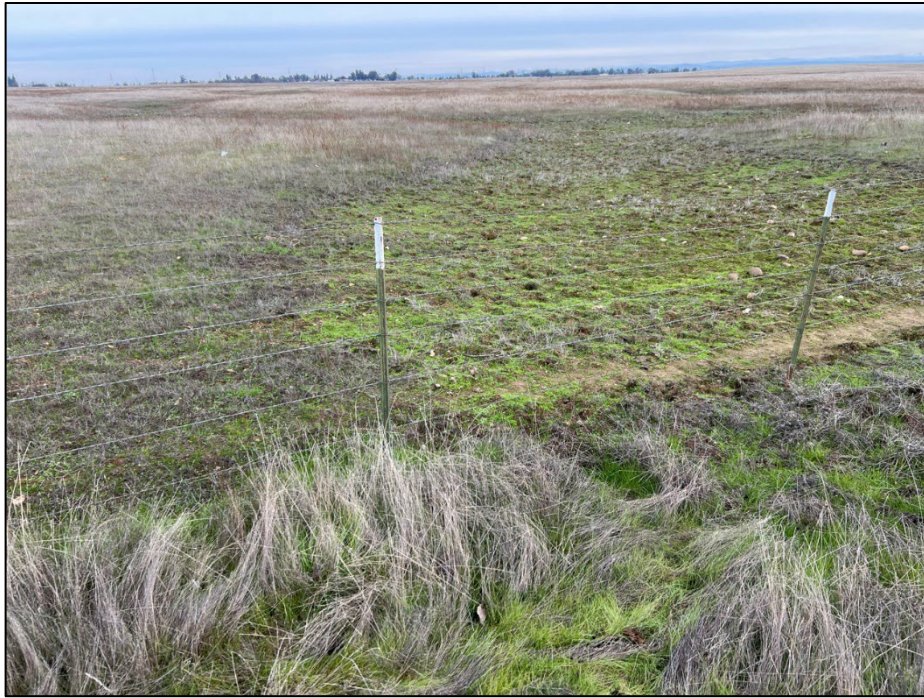
Photo 11. Vernal pool (VP-4a) is a gentle depression and occurs on the north side of Florin Road in the powerlines portion of the study area. View northeast, January 12, 2024.

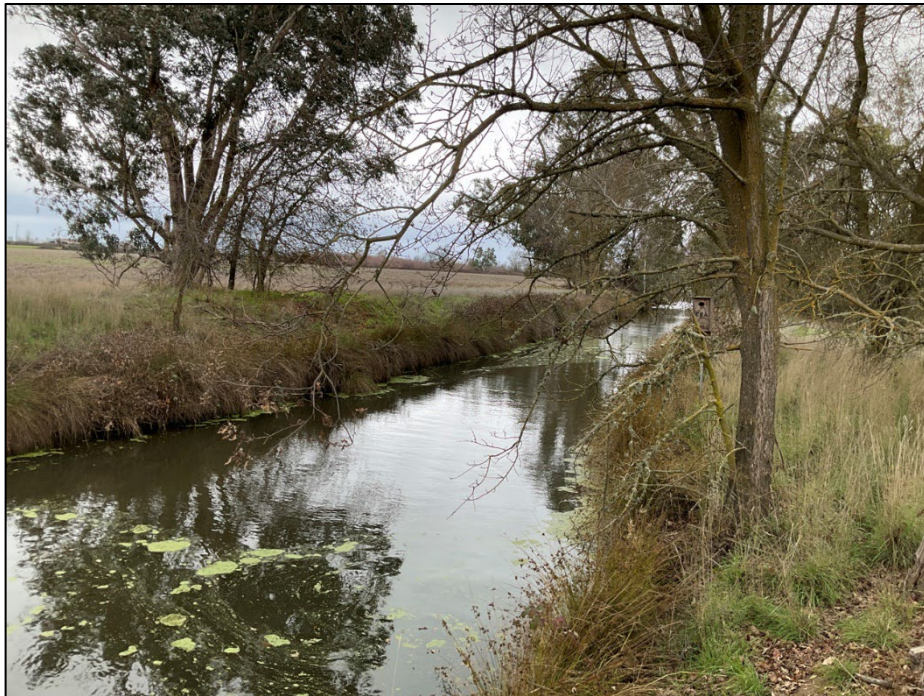
Photo 12. Laguna Creek is a perennial stream (PS-2b) after it is conveyed under Eagle Nest Road and continues to flow west. Upland riparian habitat dominated by valley oak, occurs along the banks. View west, January 10, 2024.

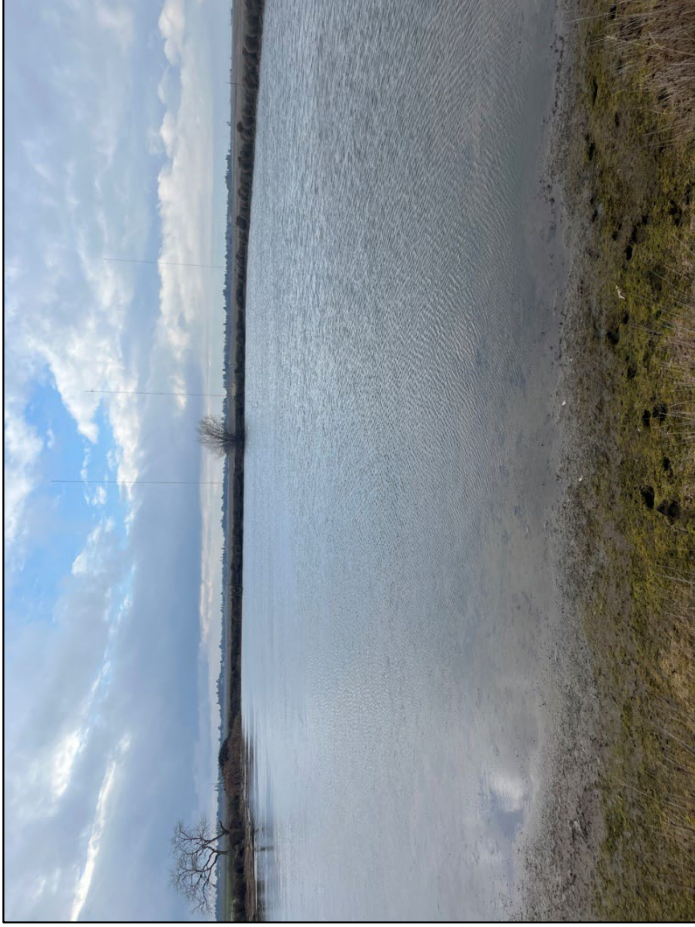
Photo 14. Pond and open water (OW-1) habitat on South Property. It supports freshwater marsh along its margin (FM-6). View west, January 10, 2024.

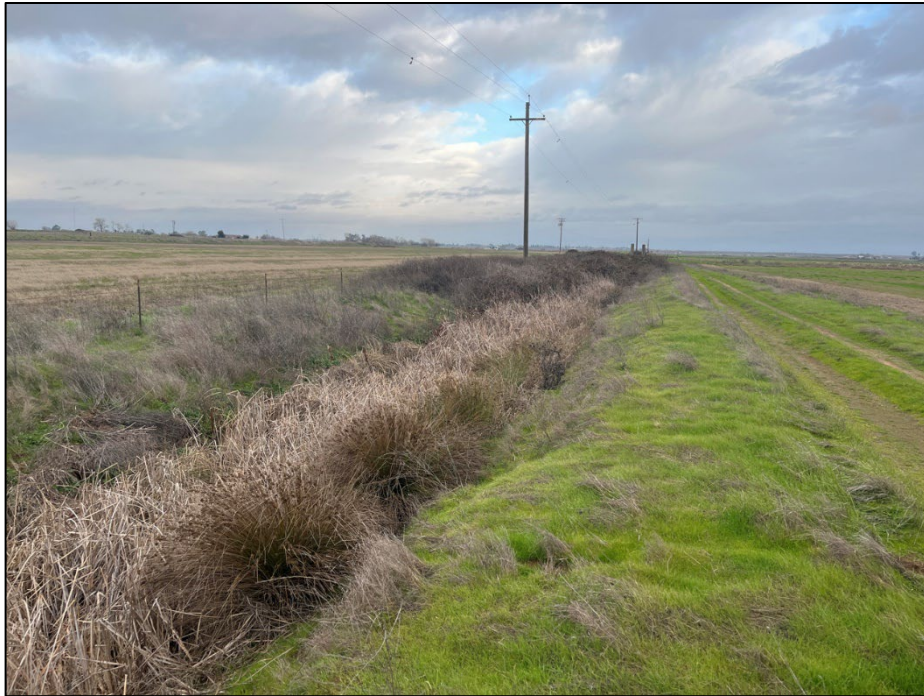
Photo 15. Agricultural ditch (AD-2b) conveys irrigation water to cropland and irrigated pastures on the South Property. It supports hydrophytic vegetation including narrow leaf cattail, lamp rush, and blackberry thickets are along the bank in the background. View east, January 11, 2024.

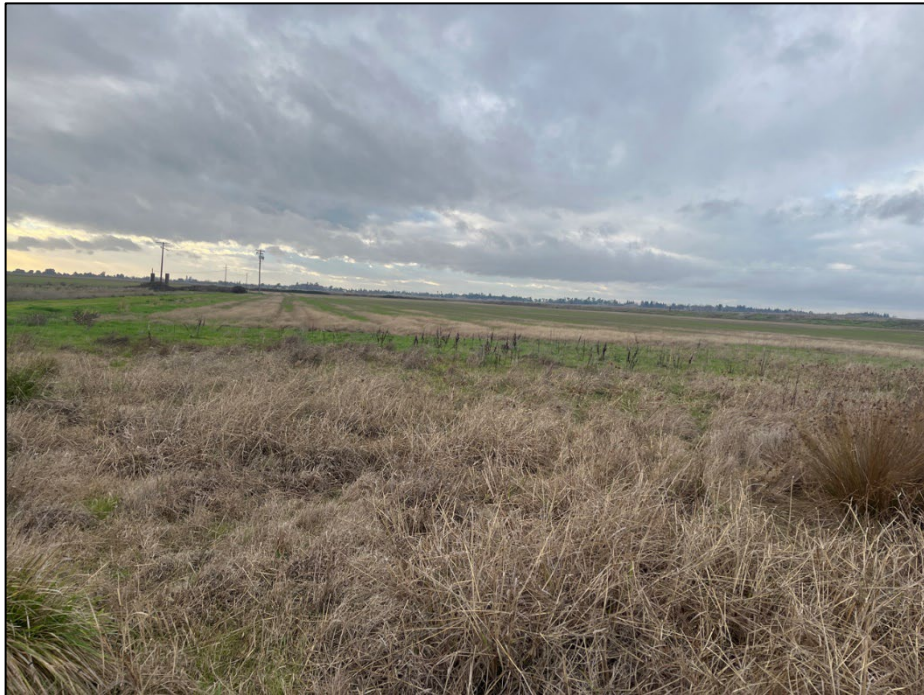
Photo 16. Hydrophytic vegetation occurs near leaky irrigation pipe in agricultural fields. Cropland landcover is in the background. View west, January 10, 2024.

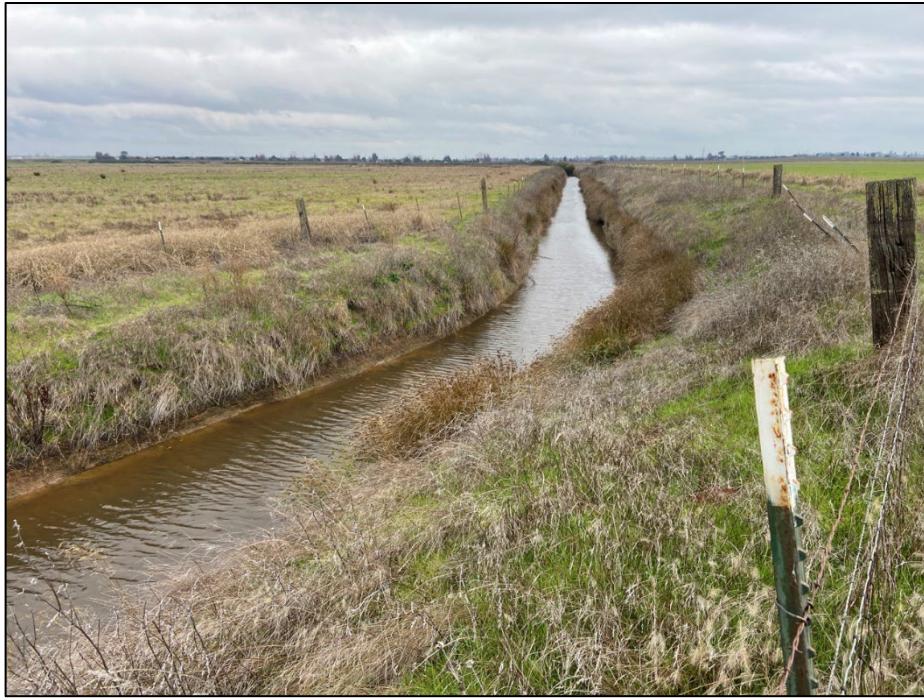
Photo 17. Large agricultural ditch (AD-3) conveys irrigation water for agricultural use on the South Property. Water is typically present year around and supports a fringe of hydrophytic vegetation along its margins. View southwest, January 10, 2024.

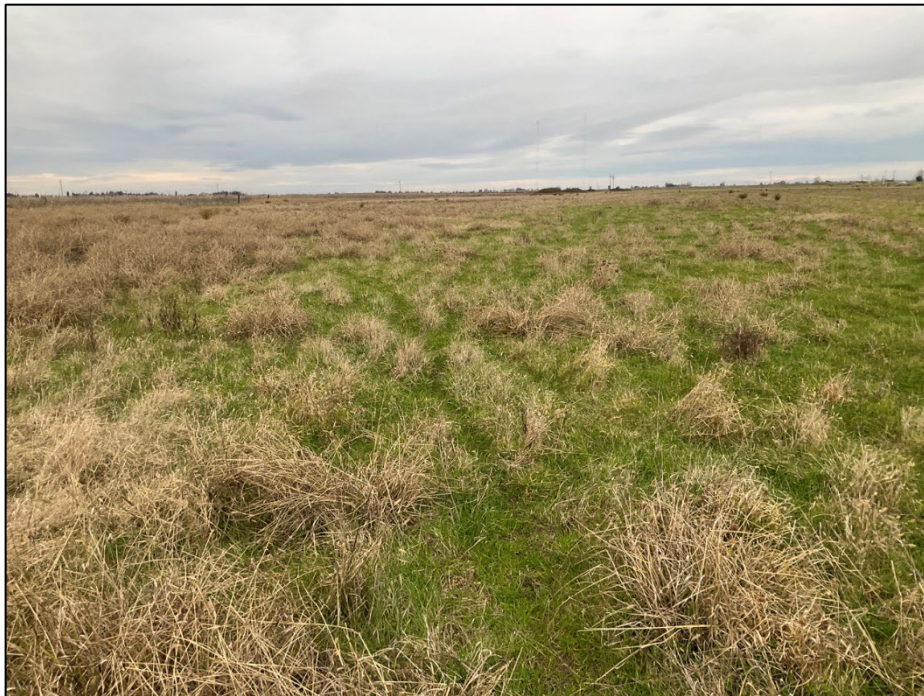
Photo 18. Cropland land cover where tall cyperus is dominant and is transitioning to seasonal wetland (SW-11) land cover to the left. View northwest, January 12, 2024.

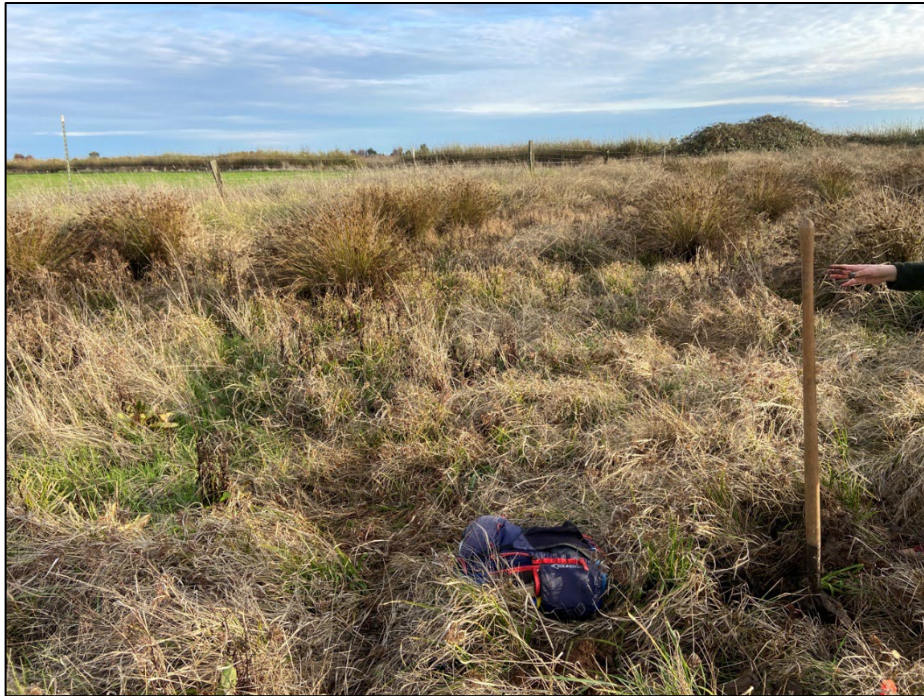
Photo 19. Seasonal wetland (SW-11) within a cropland which was dominated by old witch grass and tall cyperus and associated with Wetland Determination Data Sheet WP-4. View southeast, January 10, 2024.

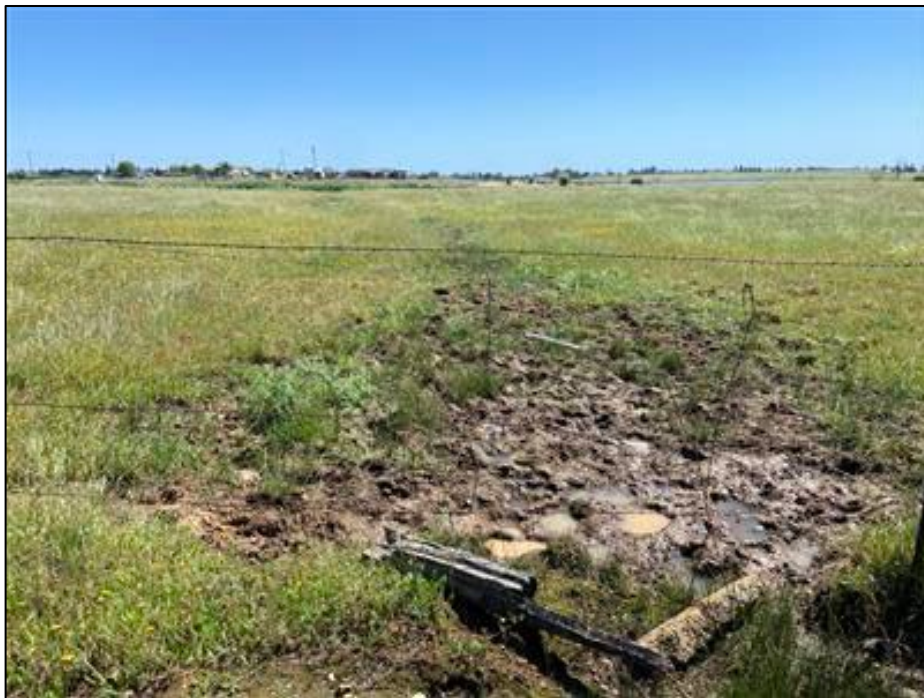
Photo 20. Swale (S-1) south of Florin Road in the northwestern portion of the powerlines of the study area. It does not support a bed or a bank. View south, May 7, 2024.

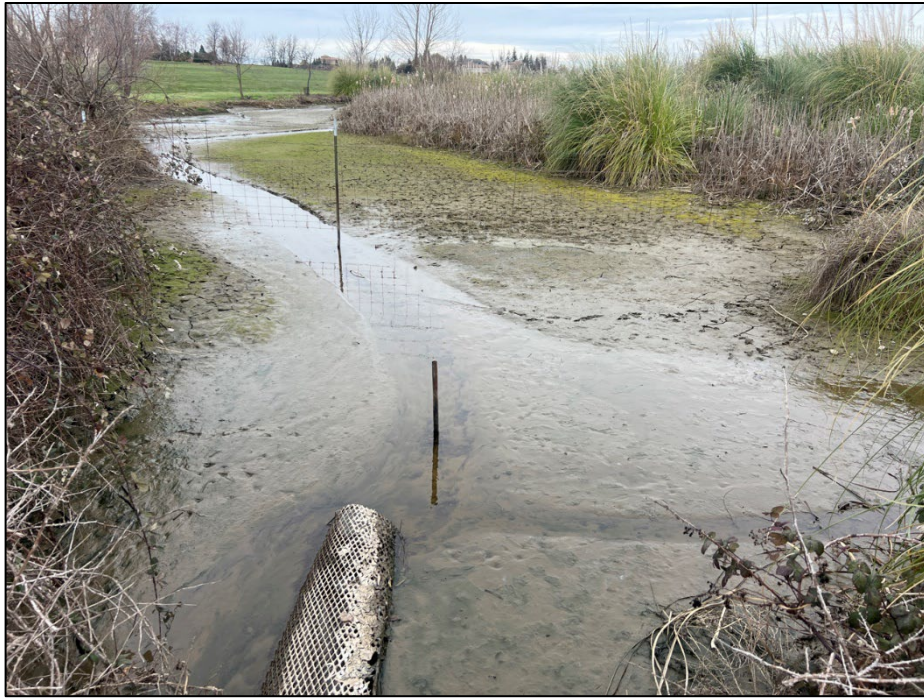
Photo 21. Intermittent stream (IS-3a) flows south and occurs on the north side of Gerber Road in the southwest portion of the powerlines of the study area. Freshwater marsh (FM-9) is in view on its eastern bank (left). View north, February 16, 2024.

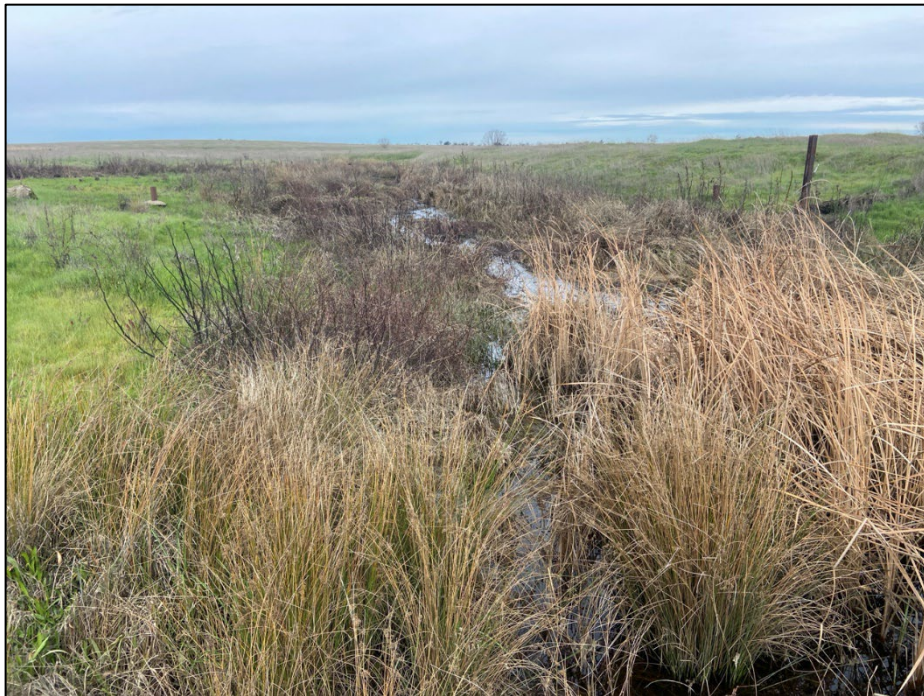
Photo 22. Laguna Creek, a perennial stream, flows through the southern portion of the powerlines of the study area. It supports freshwater marsh (FM-10) within the OHWM in this location and is composed of dallis grass, lamp rush, irisleaf rush, spikerush, and narrow leaf cattail. View northeast, February 16, 2024.

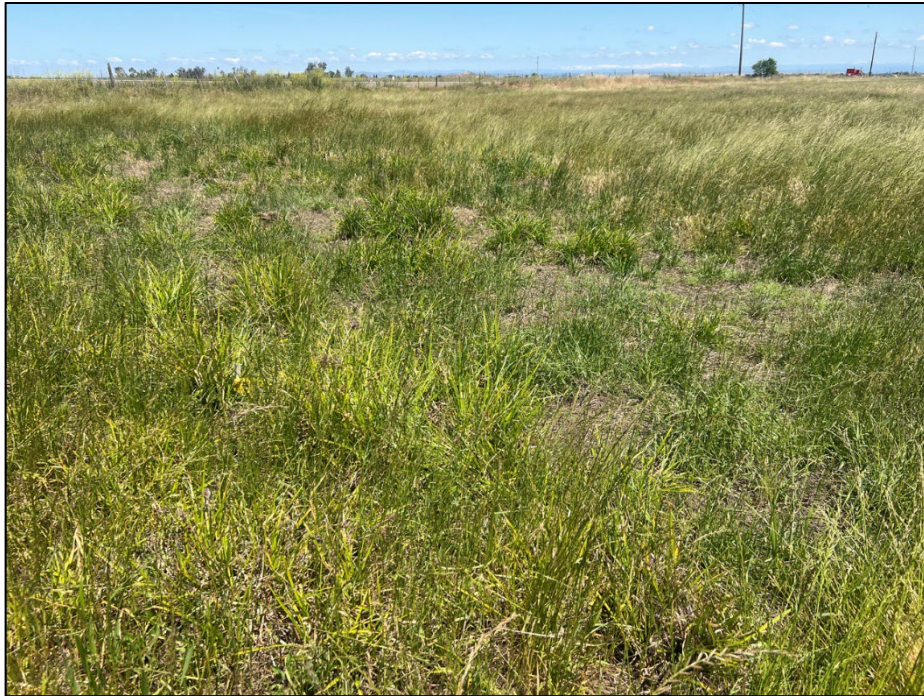
Photo 23. Seasonal wetland (SW-18) occurs in an irrigated pasture in the North Property. This feature is likely the result of ongoing agricultural practices, does not appear to be persistent through time, and therefore may not be potentially jurisdictional. View north, May 23, 2024.

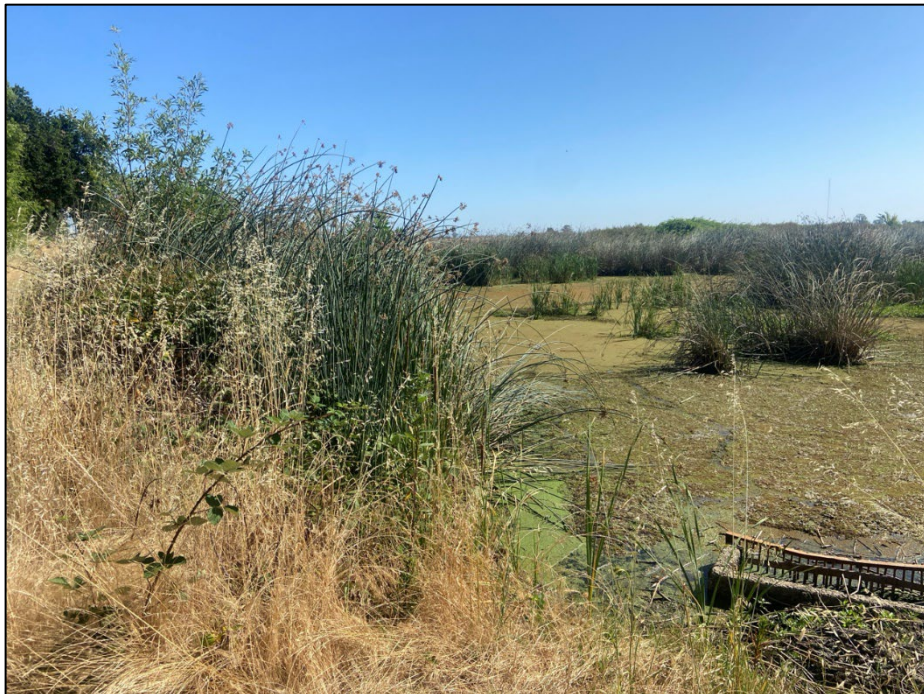
Photo 24. Laguna Creek (PS-2c) where it intersects the powerline portion of the study area between the North and South Properties. Freshwater marsh (FM-8) dominated by common tule is along the banks. View east, July 10, 2024.
