Provide an overview of the **Cosumnes Power Plant (CPP)** steam turbine generator stator ground fault failure and approve the proposed amendment to the **2022 SFA Budget Resolution** to augment the Capital Expenditures line item by \$18.61 million for **Sacramento Municipal Utility District Financing Authority (SFA)**.

Board Finance & Audit Committee and Special SMUD Board of Directors Meeting
Tuesday, October 18, 2022, scheduled to begin at 5:30 p.m.

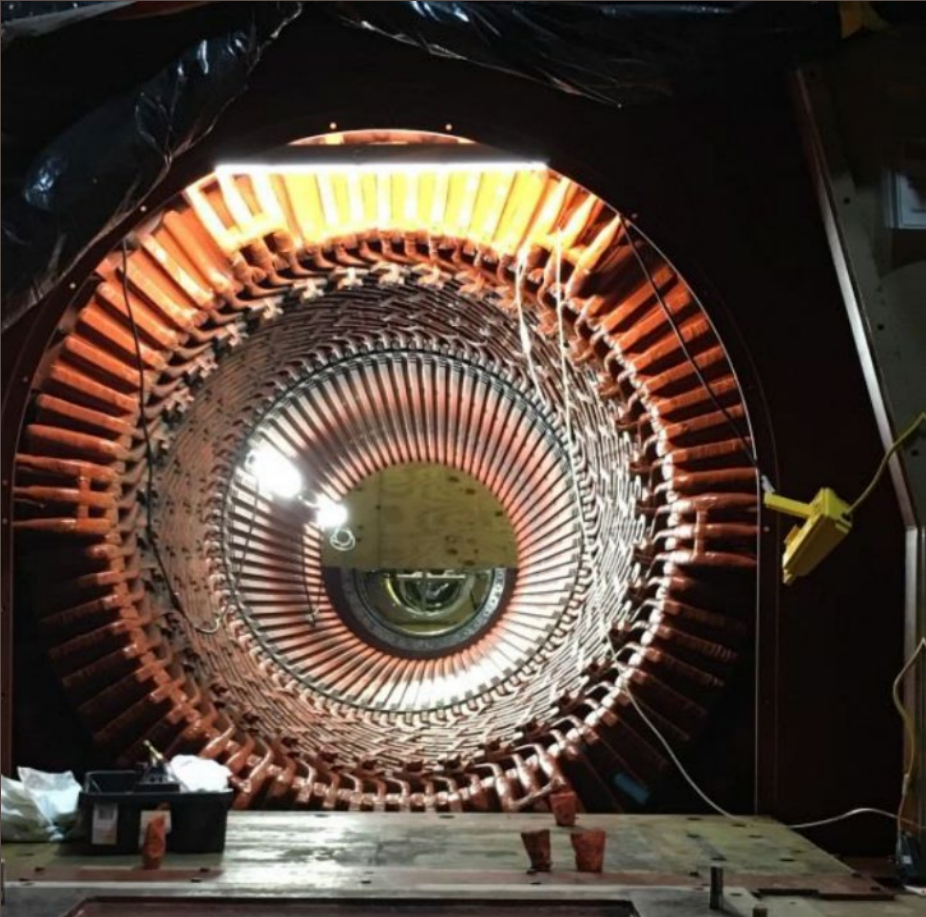
Why Air-Cooled Generators Fail

Thermal – heat generated by the working generator (thermal cycling)

Mechanical – cause by machine vibration

Electrical – caused by voltage stress

Chemical stresses – caused by the breakdown of materials, insulation (epoxy resin) and other components over time

Environmental factors

Rarely does one factor work alone to cause a problem

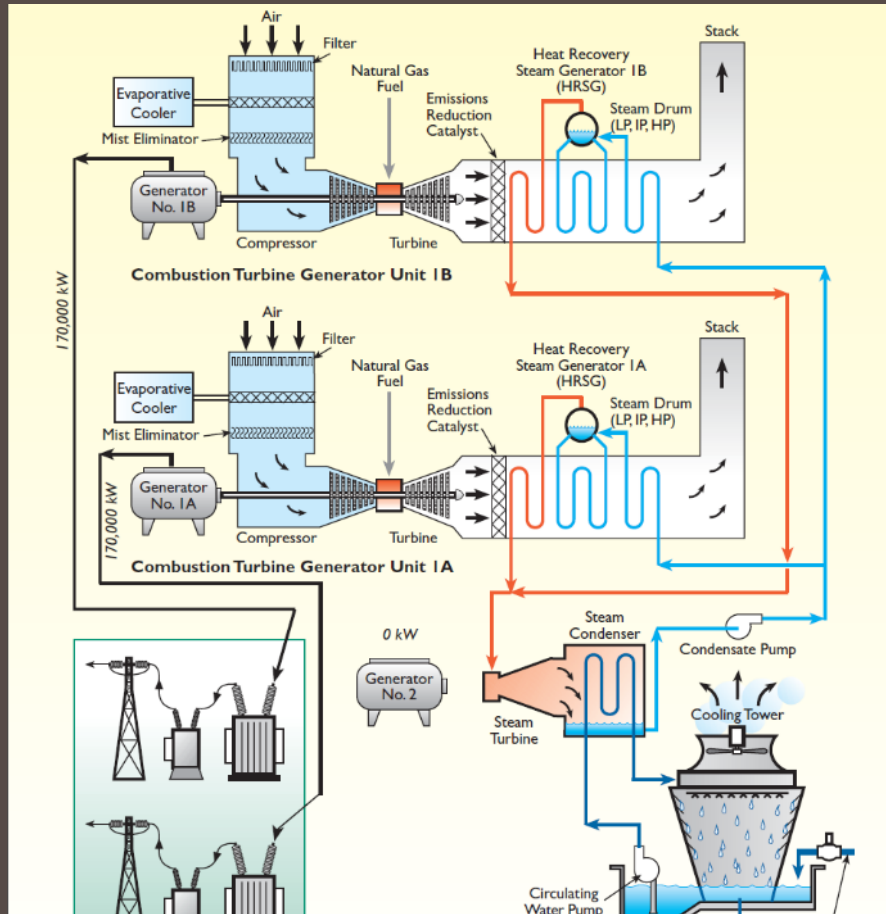
1X0 & 2X0 Operations

- Bypass Steam Turbine
 - 1X0 83 MW – 200 MW (Gross)
 - 2X0 83 MW – 280 MW (Gross)
 - Run in manual control with no Automatic Generation Control (AGC) for unit stability
